Analysis of the Crankshaft Failure of Wheel Loader Diesel Engine

The main purpose of this study is to review the cause for the crankshaft failure of six-cylinder diesel engine of a wheel loader after passing a short period of time. The failure had occurred after 4800 hours of in-service in the fifth crankpin of the crankshaft. Hardness and tensile tests were carried out to study their mechanical properties. Spectrophotometer machine was used to examine the chemical composition of the crankshaft material. To examine the material microstructure, its defects and the morphology of fracture surface, optical microscopes (OM) and scanning electronic microscopes (SEM) equipped with energy dispersive spectrometry (EDS) were used. The morphology of fracture surface showed that the fracture is of the smooth type and has occurred due to the fatigue. Main origin of the fatigue cracks appeared on the surface of the crankpin might be created by the existence of oil impurities, the impurities on the surface of the crankpin, inappropriate machining on the surface of the crankpin or severe wear and pitting from insufficient lubricating.

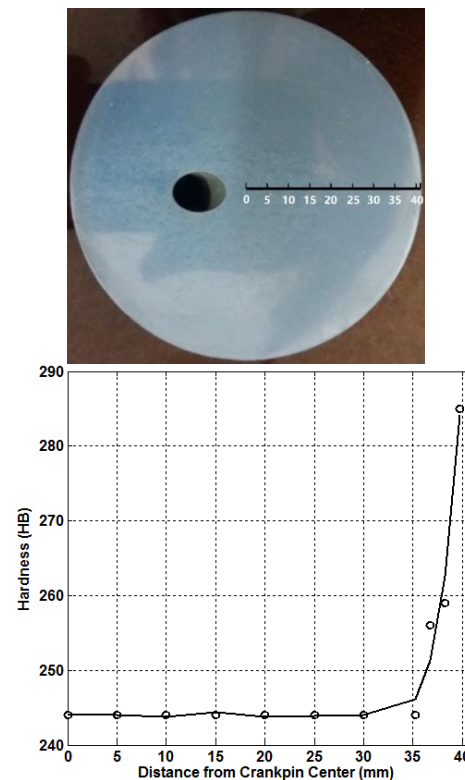
Figure 5. Hardness distribution from center to outer diameter of the crankpin.

The hardness increasing from the center of the crankpin to its surface is due to the faster cooling of the surface of the crankpin relative to the central regions, which causes the residual stress between the two surface and central regions. Therefore, one of the reasons for fatigue crack initiation is the lack of hardness uniformity between the surface and the center of the crankpin, which can be a factor in the fatigue crack initiation.

A review of the studies done on the examining the broken crankshaft of a six-cylinder diesel engine of a wheel loader was carried out. The failure of the crankshaft had happened after 4800 hours in-service on the fifth crankpin of the crankshaft. The examination done by using OM showed that the steel microstructure is of martensite type, showing the lots inclusions of on the cross-section of the polished crankpin. Micrographing crankpin no.5 after being etched showed that the few changes in the grain structure in the outer radius relative to the crankpin center are seen and the hardness diagram confirms this fact. SEM equipped with EDS was used to study the fracture surface and failure cause. The morphology of fracture surface showed that fracture is a smooth one and it has happened because of the fatigue caused mainly by the rotational bending loads. The fact that the final fracture zone is near the surface, the stress put in the surface is so close the fatigue limit. Due to the hardness results, surface hardness is more due to the more cooling rate than the central zones, which, of course, causes residual stresses between the two zones. SEM images also show the incidence of striations between two zones with different hardnesses. Therefore, in order to reduce the residual stresses, it is recommended that after forging crankshaft, stress relieving is carried out at a temperature of 500-550 °C.

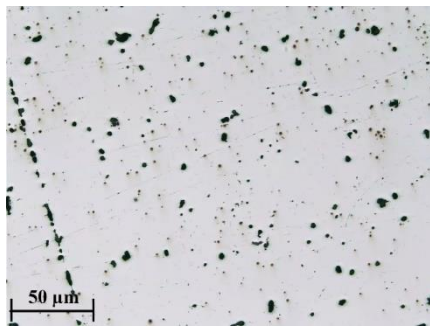
A cross-section microstructure of crankpin was observed using OM. Figure 6 shows the micrograph of the crankpin no. 5 after polishing with 1000x magnifications. The oxidized inclusions are found in great amounts on the polished areas. Figure 7 shows the micrograph after being etched. The tempered martensite structure was observed which hardness measuring approves the results.

Figure 6. Micrograph of the material as polished with 500x magnifications

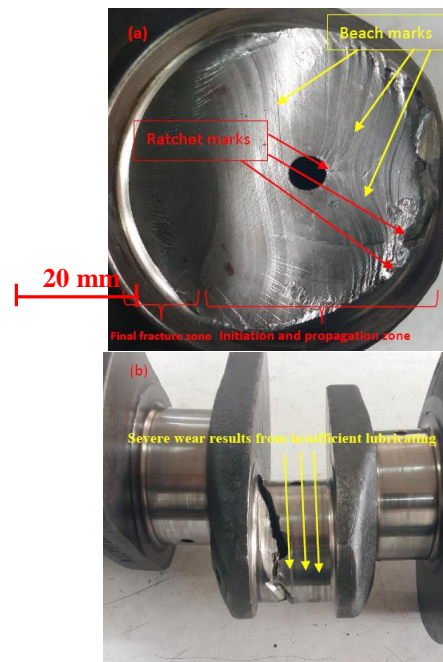
Figure 8 shows the fracture zone of the broken crankpin of the wheel loader of the crankpin-web fillet root. This has happened after 4800 hours in-service. The morphology of the fracture surface shows that it is of a smooth type and it has been caused by the fatigue being affected by the rotational bending load. The fracture surface includes two zones: (1) the crack initiation and propagation zone with beach marks and ratchet marks; and (2) final fracture zone in front of the crack initiation zone. Figure 8.a shows the fatigue crack initiation position on the cross-section of the broken surface. Main origin of the fatigue cracks appeared on the surface of the crankpin might be created by the existence of oil impurities, inappropriate machining on the surface of the crankpin or severe wear and pitting from insufficient lubricating or it might be because of other impurities on the surface of crankpin as polished image shows it might be of oxidized inclusions type. The fact that the final fracture zone is near the surface, the stress put in the surface is so close the fatigue limit.

Comparing the fractured surface of Figure 8 with the schematic guidelines of Figure 9 on the fracture surface of the shafts [17, 18], the following specifications can be referred to: (1) high cycle; (2) low stress with the small zone of the final fracture compared to the wide cross-section of the whole crankpin due to the cyclic stress caused by rotational bending loads; and (3) a medium stress concentration.

Figure 8. (a) Photograph of the failed crankshaft at the fifth crankpin; (b) The fractured surfaces of the crankshaft at the second crankpin

According to the crack initiation and propagation zone and the final fracture zone of the Figure 8, the amount of rotational load compared to bending load is negligible.

In order to prevent the occurrence of such problems, it is recommended to change the oil within a specified period. It is also proposed to use better quality and reduced impurity steel as much as possible. Also, the quality of the machining surfaces must be checked to ensure that there won't be any rough and deep lines in the surface.

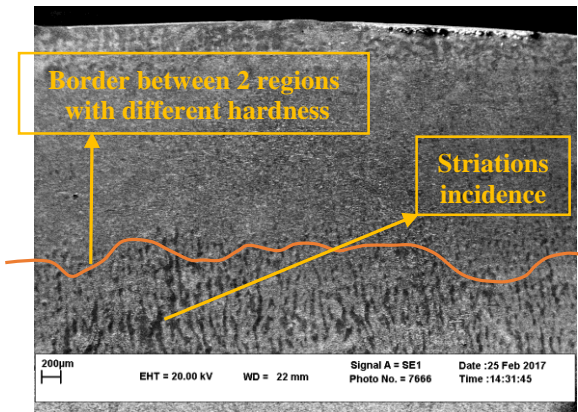
To examine the more precise origin of fracture of Figure 8, SEM images along with EDS with different magnifications were prepared. First the sample was put in ultrasonic bath and the Figures 10 and 11 were prepared. Figure 10 shows the incidence of striations, which are the marks of fatigue.

Figure 10. SEM micrograph of the fatigue marks with 70x magnifications.

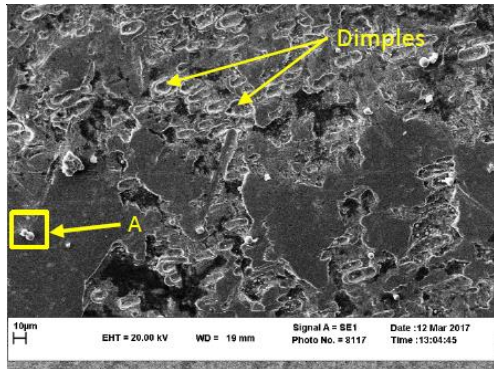
Figure 11. SEM micrograph of the crack after ultrasonic bath with 500x magnifications

Figure 11 shows the fractography of SEM which is one of the features of the dimple fracture.

A series of particles such as A were observed on the fracture surface. The fact that the metal particles of A are seen on Figure 11 on the fractured surface, Figure 12 was prepared from the other side of the fractured surface of the crankpin without being put in the

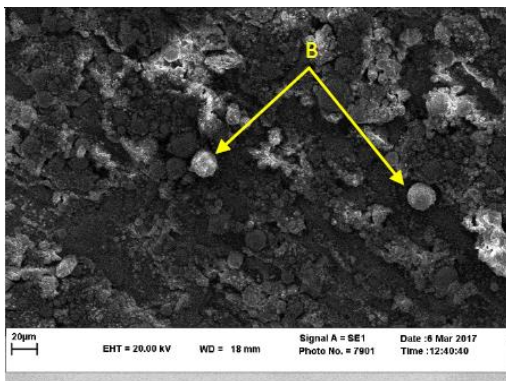
Figure 12. SEM micrographs of the crack before ultrasonic bath with 1000x magnifications

ultrasonic bath. The result was that metal particles of B was reappeared.

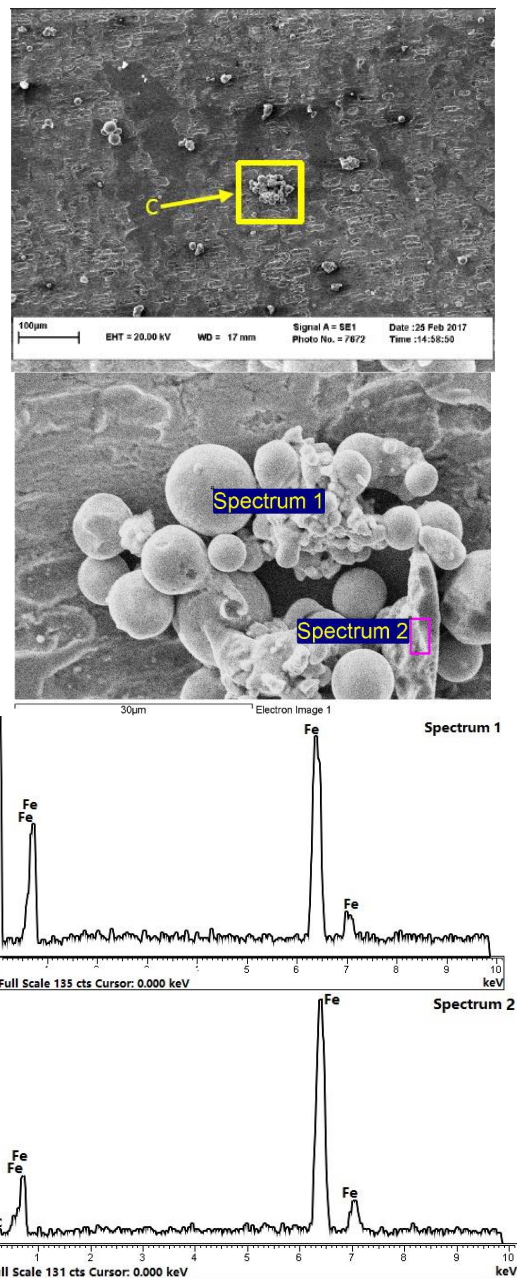
Then another photograph with 2000x magnification was taken and the EDS from the materials of square C was prepared (see Figure 13). This is not an impurity; but, it might be the remaining materials from the severe wear of the two sides of the broken crankpin while in-service or the cutting process for preparing of the sample by wire-cut machine. The similar particles of this research have been observed in the literature [19].

Figure 13. Micrographs of the crack after ultrasonic bath with 2000x magnifications.
