Corrosion Failure Study in an Oil Cooler Heat Exchanger in Marine Diesel Engine

In this article, the failure of a heat exchanger during its operation in the marine environment has been analyzed. This heat exchanger was used for cooling the oil in a marine diesel engine. Based on the existing failure history, damages in engine components were observed after 89 hours of engine working due to the leakage of the sea water to the oil. For the objective of the failure analysis, each component was investigated under the stereo optical microscopy and the scanning electron microscopy (SEM). The diameter of pits was also recorded as 8 micrometer. Besides, the chemical composition of corrosion products on the surface and in pits was additionally analyzed with the energy dispersive X-ray spectroscopy (EDAX). Results indicated that two corrosion mechanisms were failure root causes of leakages, including the crevice corrosion and the pitting corrosion. In such situation, in the engine, the oil and the sea water in tubes of the heat exchanger mixed and decreased the oil viscosity and damaged the oil film on crankshaft bearings, and finally caused damages of the engine.

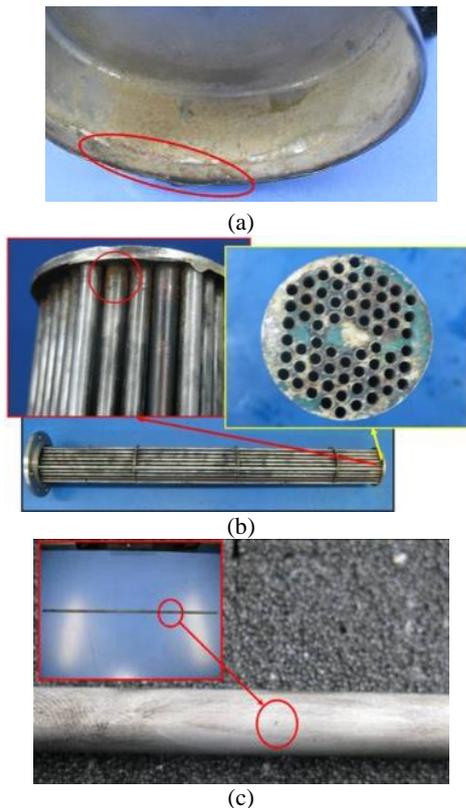
After 38 hours of engine working, the oil volume reduced. By continuing upto 89 hours, failures were observed in crank shaft bearings. The cause of this failure was the reduction in the oil volume due to leakage in the oil cooler heat exchanger. During a leakage test, as an observation, leakage effects were seen on the hub exposed to the sea water with rust effects (Figure 2a).

Another leakage was observed between tubes and the tube sheet (Figure 2b). The joint between tubes and the tube sheet in one side in was the sea water environment and in other side, in the oil environment, where rust effects can be seen. At another instance, after the disassembly of tubes, tiny holes were observed on the external surfaces of tubes, (Figure 2c).

Figure 2. Leakage regions (a) in the hub, (b) between tubes and the tube sheet, (c) on the external surfaces of tubes as tiny holes

5.1. The Leakage in the Hub Figure 2(a) shows the presence of salt deposits in the hub. Factors that created these salts often include the solubility reduction of salts (such as magnesium or carbonates salts) at high

As shown in Figure 2(b), the damage was normally confined to the brass sheet, at localized areas between tubes and the tube sheet. The damage was from the side that the joint area of tubes and the tube sheet was in the sea water. Rust effects on the oil side of tubes were due to engine working for 89 hours, after the oil volume reduction at 38 hours of working. The reason for the mentioned damage was the sea water reverse osmosis desalination plant. It seems that the damage was of the crevice corrosion type, since common locations for the crevice corrosion in heat exchangers could be at a gap between tubes and tube sheet or at gasketed joints (Figure 3).

5. 3. The Leakage in Tubes The leakage in tubes of the heat exchanger was clearly observed, as shown in Figure 2(c). In order to study this phenomenon deeply, tubes were sectioned. Images of the inner tube surface under the stereo optical microscopy were seen. As shown in Figures 6 and 7, tiny holes in tubes were created in the internal part (exposed to the sea water) and then continued to the external part (exposed to the oil). The reason is that chlorides as one of the contents of the sea water are corrosive. In other words, these holes or pits were caused due to the localized corrosion. In particular, it was a pitting corrosion.

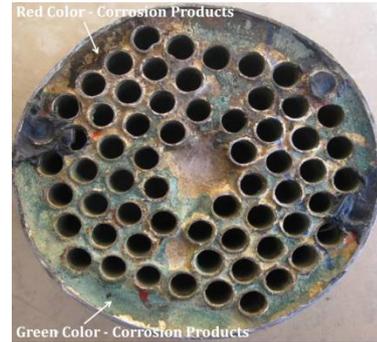
Such rusts may result in $[\text{Fe}^{\text{II}}_3\cdot\text{Fe}^{\text{III}}(\text{OH})_8]^+ [\text{Cl}\cdot\text{H}_2\text{O}]^-$, a series of iron hydroxides [15]. EDAX results indicated the presence of chlorine in 6.09 %wt., iron in 3.88 %wt., and oxygen in 2.25 %wt. in green color - corrosion products. Comparing EDAX results for green and red rusts, it could be concluded that the chlorine concentration in the green rust was about two times higher than the same content in the red rust. The de-passivation of stainless steels to form green rusts occurs when the ratio of concentrations of chloride ions to hydroxide ions is greater than 1, as mentioned in the literature [15]. This ratio was about 2.7 as shown in EDAX results.

Figure 4. Red color and green color - corrosion products on the tube sheet

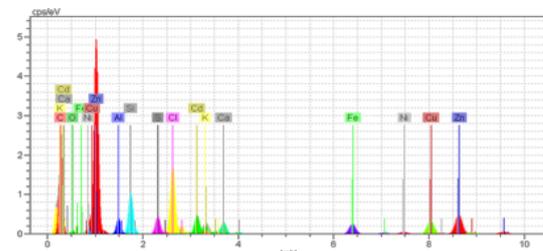
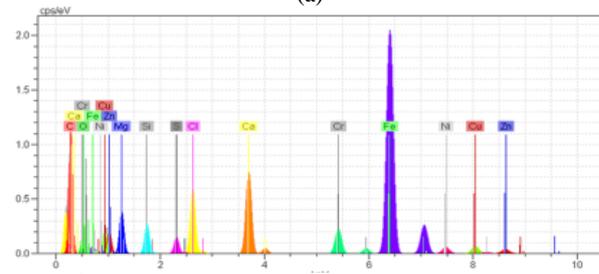
Figure 5. EDAX results for the tube sheet, including (a) green color and (b) red color - corrosion products

The formation rate of corrosion products and the proportion of components depend upon the humidity and the amount of air pollutants. EDAX results showed the presence of carbon in 32.91%wt. and sulfur in 1.41 %wt. Therefore, this brass was not suitable for sea water, when the working temperature exceeded 45°C [16]. Naval brass (Cu-38Zn-1Sn) or aluminum brass (Cu-22Zn-2Al) is now practically the only brass used for the sea water heat exchanger. For the red rust, two distinct electrochemical reactions occur. There is an anodic dissolution, or oxidation of iron going into the aqueous (water) solution.

Iron oxides react with oxygen to yield the red rust, $\text{Fe}_2\text{O}_3 \cdot \text{H}_2\text{O}$. EDAX results for the red rust showed the presence of chlorine in 2.66 %wt., iron in 56.92 %wt., and oxygen in 3.96 %wt.

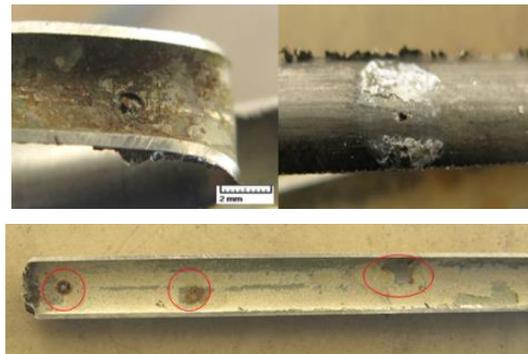
Figure 6. Optical microscopy images of the leakage region in the tube of the heat exchanger

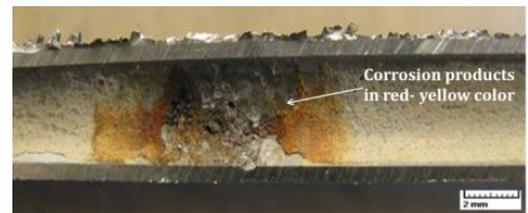
Corrosion products were adhered to internal surfaces of tubes, leading to the rusty appearance (Figures 7). Pits on the internal surface of tubes were obscured by corrosion products (the iron oxide). The pitting corrosion could produce pits with their open mouths (uncovered pits) or could be covered with a semi-permeable membrane of corrosion products [17].

Figure 7. Optical microscopy images of the leakage region with corrosion products

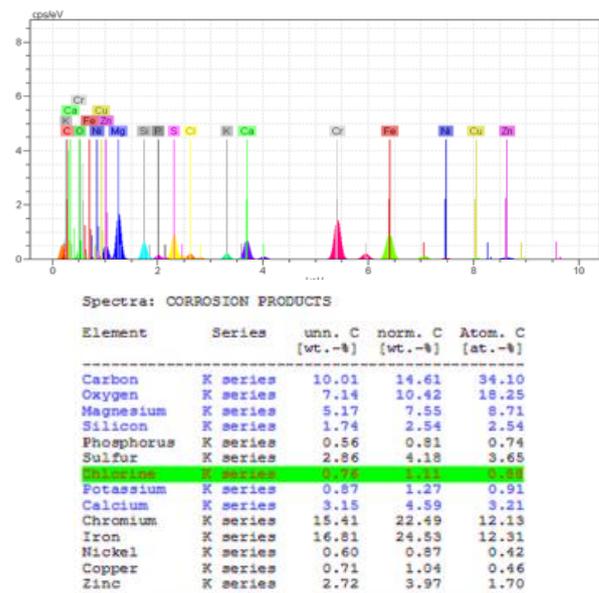
The EDAX resulting corrosion products can be seen in Figure 8. Corrosion products include oxygen and iron, which are rusty effects as Fe_xO_y . In this pattern, chlorine and calcium also were presented in about 1.11 and 4.59 %wt., respectively. In other words, chlorine and calcium which came from the sea water were trapped in corrosion products.

Figure 8. EDAX results for corrosion products

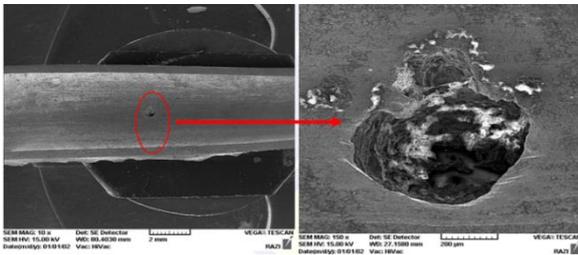
The size of pits was less than 200 micrometer, as shown in SEM images (Figure 9). This pits size was obtained after 89 hours of engine working. It seemed that pits were aggregated together and created a new tiny hole, which the overall size reached above 400 micrometers. The shape of pits was elliptical.

Figure 9. SEM images of pits in the internal part of the tube

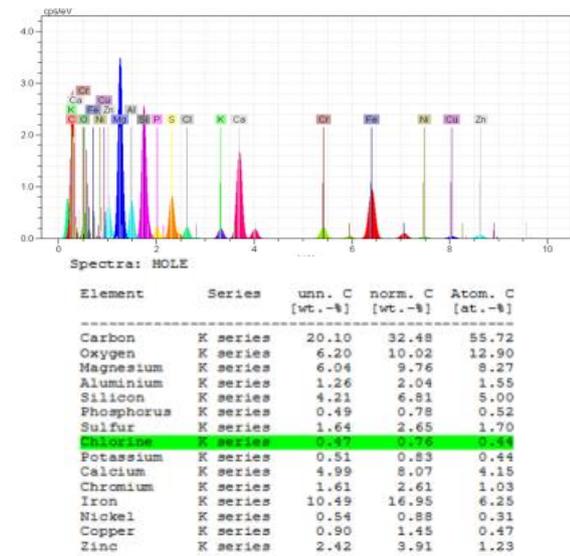
The results of elemental analysis by EDAX (Figure 10) indicated that there were about 10.02 %wt. of oxygen and 0.76 % wt. of chlorine in tiny holes and pits. Adsorbed chloride ions broke down the passivity of the stainless steel, thus increased the corrosion rate. The adsorption process of chloride on metal surfaces has been demonstrated by other researches [17, 18]. In addition, pits in the stainless steel are often associated with manganese sulphide (MnS) inclusions which are found in most commercial steels. The role of MnS inclusions in promoting the breakdown and the localized corrosion of stainless steels has been reported in the literature [17].

Figure 10. EDAX results for tiny holes and pits

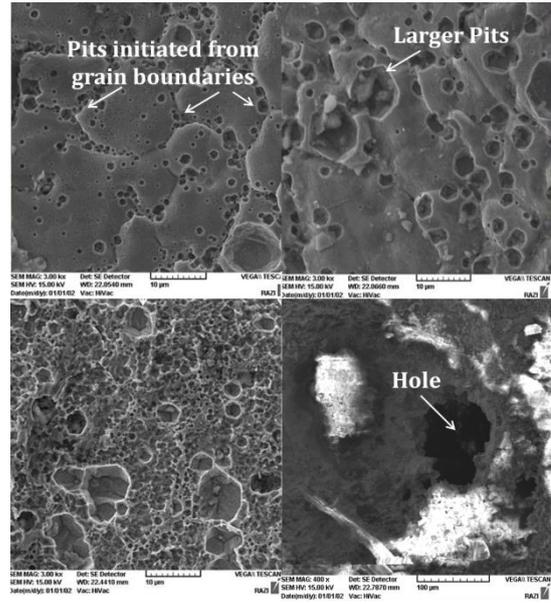
Figure 11 shows the pitting corrosion at different regions of the tube. Pits were initiated from the grain boundary of the austenite phase in stainless steels, as these sites had higher energy compared to the grains. As shown in Figure 7, the minimum size of pits size was about 1 micrometer. The maximum size of pits would be 8 micrometers.

Figure 11. SEM images of pits in the internal part of the tube

Such pits were made after 38 hours of engine working. In some situations, some pits were aggregated together.

The higher the *PREn* number, the better the performance of an alloy in chloride environments. The *PREn* number for tubes was 24 and this was lower than the range of the protection. The *PREn* number should be more than 32 for the sea water [14]. Therefore, the 316L stainless steel is not suitable for marine environments. It is suggested that the alloy 20 stainless steel (a nickel-iron-chromium austenitic alloy: super alloy) with the *PREn* number higher than 33 or 254SMO-1.4547 (a 6% molybdenum and nitrogen-alloyed austenitic stainless steel) with the *PREn* number higher than 43 could be suitable for such case [19].
