## TECHNICAL NOTE

# AN INVESTIGATION ON THE CAUSES OF A ROTOR BENDING AND ITS THERMAL STRAIGHTENING

*E. Poursaeidi\**

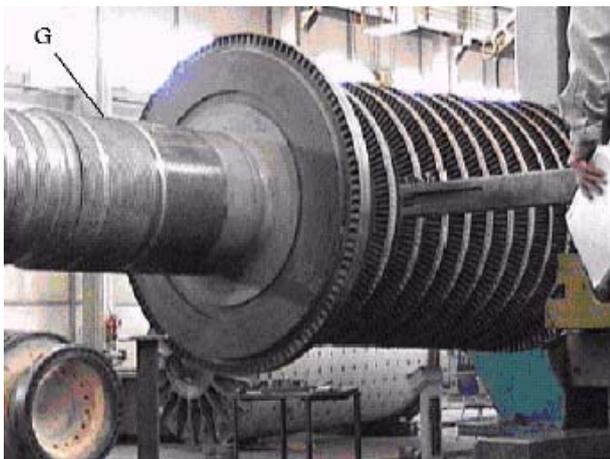
In September 2000 a straightening project was performed on a 200 MW steam turbine. A typical view of this bent rotor has been shown in Figure 1. The aforementioned rotor has been in service for about 90000 hr, after which the Russian manufacturer overhauled it. After the last overhaul the rotor was put back into service but when it reached about 500 RPM, the sealing which was near the coupling was touched. Subsequently a run-out check had been performed and showed that the rotor suffered a kind of distortion. To correct the axial run-out on the coupling end, some shimming plates were added between the HP-and LP rotor coupling. Then the rotor was put back into service again. This time the rotor was run up to

Figure 1. The bent rotor in shaft area (denoted by G).

**3.2. Initial Run-Out Test** In order to determine the extent of distortion i.e. bending, an initial run-out test was performed on 15 points of the rotor. Results of initial run-out indicated that the rotor had a maximum run-out about 0.45 mm at the position denoted by G (refer to Figure 1). It was also observed that, the position of high bending was exactly 180° away from rubbing marks on the rotor. As a final result from initial evaluation, it can be claimed that, the major causing of bending in the considered rotor, has been the rubbing, owing to the loss of clearance between rotating shaft and stationary parts. Of course, there are many reasons for the loss of clearance between rotating and stationary parts in the turbine. Three of the major reasons are listed below in the frequency of importance:

spot of sliding surfaces exactly 180° away from G (the same maximum point of bending). The friction caused local heating in denoted area and the following occurred, localized thermal expansion and the resulting rotor bend had increased the pressure intensity and the extent of it ran in a progressive manner.

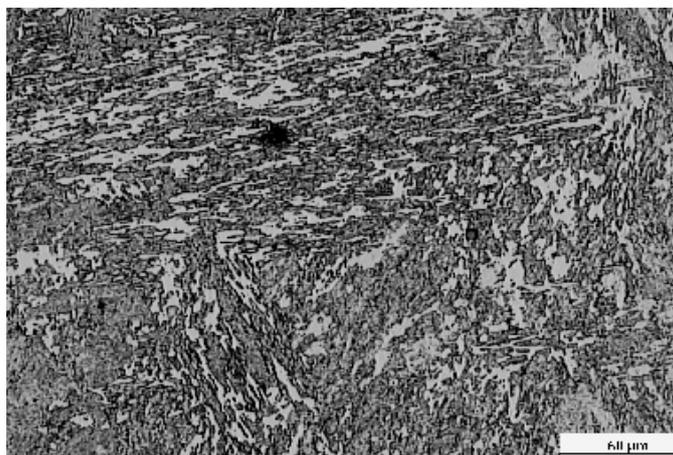
**Figure 2.** The bainitic structure of bent rotor (taken by replica).

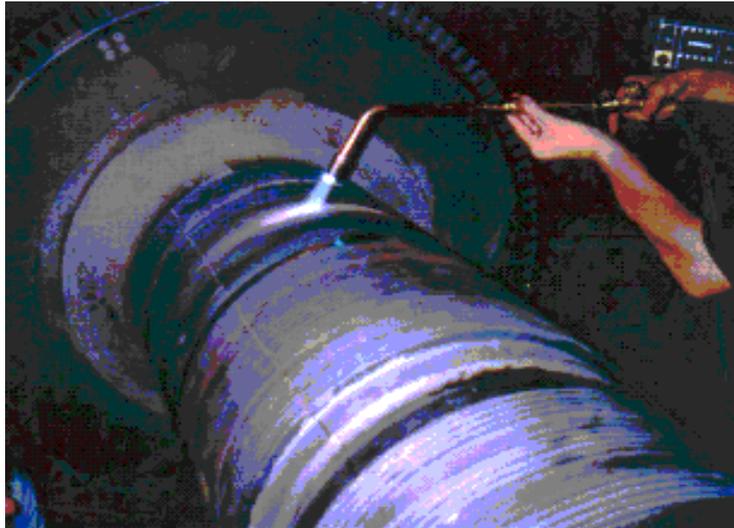
**Figure 3.** The mechanism of hot spotting heat treatment.

This thermal process was performed seven times which is showed in Figure 3 (each time at the same maximum point of bending). To carry out the hot spotting, the rotor was put in the lathe with the maximum location of bending point. A dial indicator was positioned exactly 180° away from the hot spot area (i.e. underneath the rotor). During the hot spotting of the rotor, the deflection behavior versus time was recorded. Detail information about each 7 steps of hot spot is showed in Table 3.

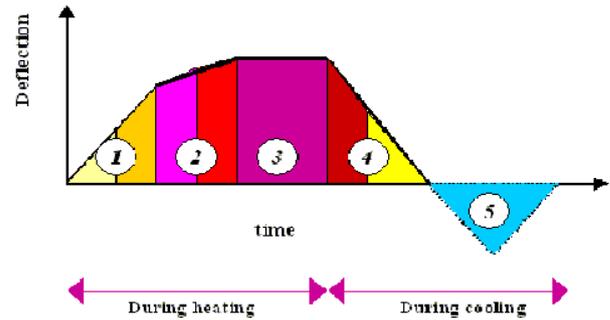
Figure 4. Ideal variations of bent rotor during hot spotting.

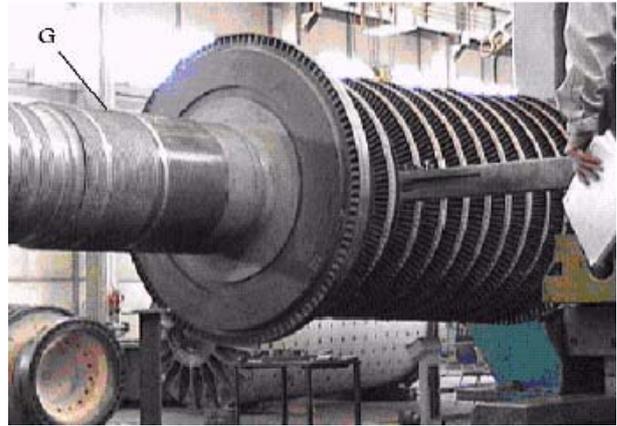
**Figure 5.** Utilization of locally hot spotting on bent rotor without any insulation.

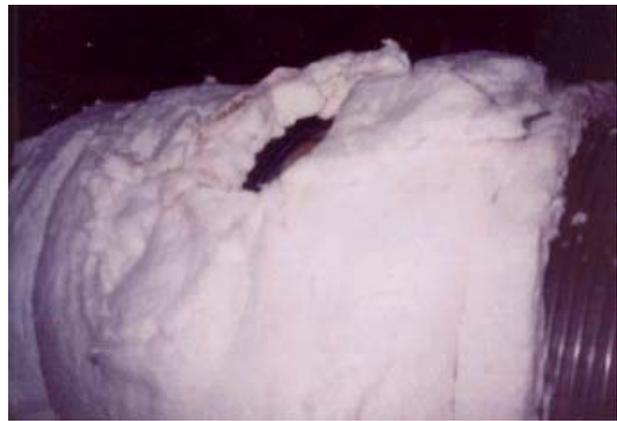
**Figure 6.** Utilization of locally hot spotting on bent rotor with dry insulation.

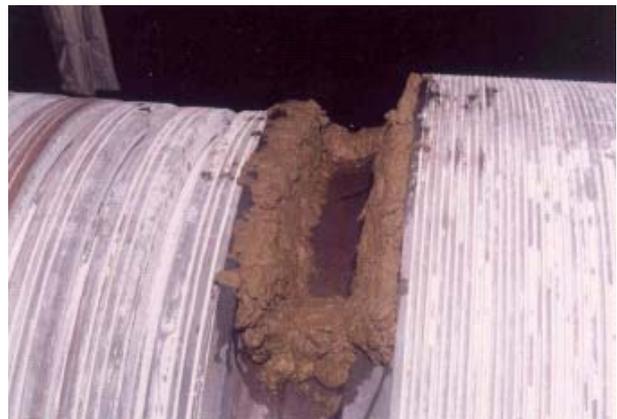
**Figure 7.** Utilization of locally hot spotting on bent rotor with moisture insulation.

According to the presented data in Table 3, the application of moisture insulation in selected metal temperature  $690 \pm 20^\circ\text{C}$  and time (210 S.) has the most influence on straightening the bent rotor. By this sequence, the effects of restraint severity were simulated by F.E.M in view of heat distribution and upsetting result.

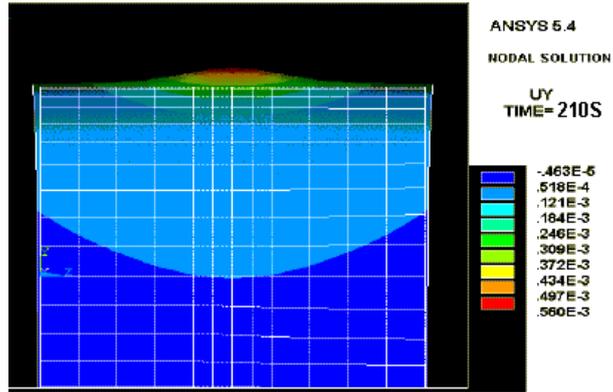
Upsetting Without Isolation

Figure 8. The occurred upsetting values in the lack of any insulation.

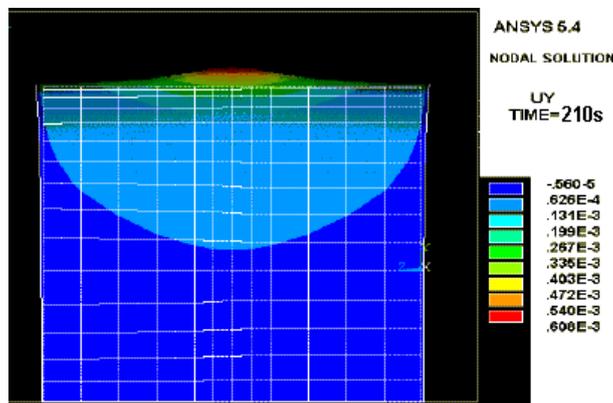
Upsetting Wit Dry Isolation

Figure 9. The occurred upsetting values in the lack of any insulation.

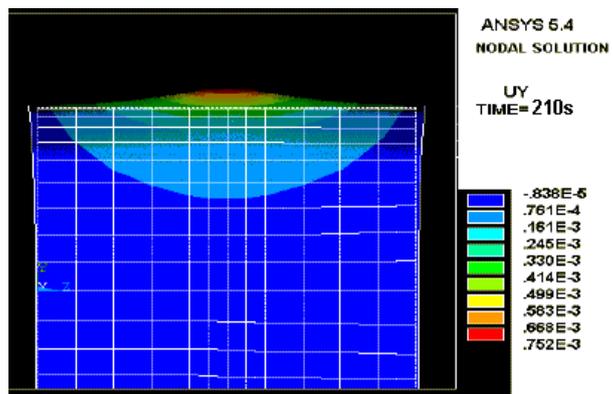
Upsetting Wit Wet Isolation

Figure 10. The occurred upsetting values in the lack of any insulation.

- ❖ The results of experimental investigation by F.E.M indicated that, the maximum restraint effects are obtained by using moisture insulation around the hotspot for more upsetting (0.75 mm). Case study of this analysis showed that, the upsetting value in dry insulation is equal to 0.69 mm and in the state of without insulation is equal to 0.56 mm. So, according to above results, it is proposed to perform hot spotting by moisture insulation around the hot spot area to obtain optimum restraint effects.
