## Life Estimate of a Compressor Blade through Fractography

In this paper, fatigue life will be estimated based on the relationships between striation spacing and crack growth rate. The power plant under investigation in this paper is established in a coastal area in south IRAN. It is equipped with four 40 MW Frame 6 type gas turbine engines which are named GTG A, B, C and D that have been installed in less than a decade. GTG D was tripped by a violent sound due to compressor failure. GTG A and B had failed earlier with similar catastrophic events.

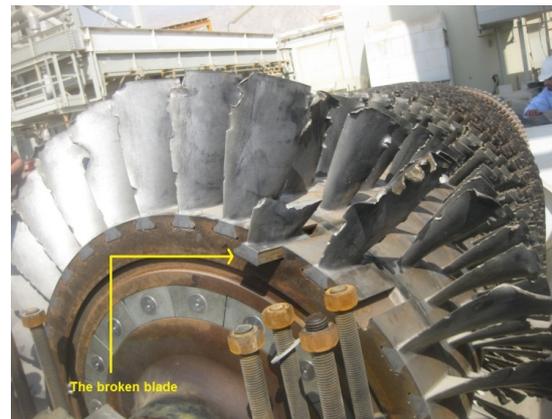
**2. 1. Properties of Compressor Blade** The working time of the GTG D compressor was 26780 hours. Preliminary observations such as failure of a moving blade in the 1<sup>st</sup> row and damages on other moving and stationary blade indicate that the incident occurred in the GTG D compressor was similar to the previous events on the other compressors of the unit. Figure 1 shows the following failure status of the incident at the compressor inlet. In this figure, the remaining part of the broken blade on the rotor can be observed. Analysis and visual inspection indicated that a moving blade of the 1st row was first destroyed (broken). Other stationary and moving blades were observed with damage by solid objects and particles, which originated from the destroyed blades of the 1st row.

Figure 1. The fractured blade and other damaged blades.

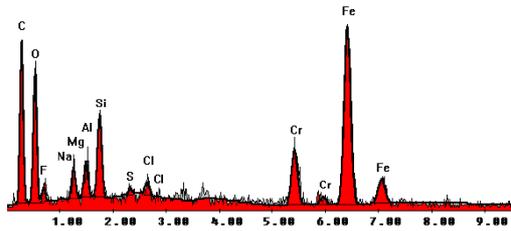
EDAX chemical analysis using SEM in pitting locations showed that there are many non-structural elements such as S, Cl and Na. It should be noted that no surface cleaning was done at this stage for chemical analysis. The results are shown in Figure 2.

Figure 2. Chemical analysis of the broken blade

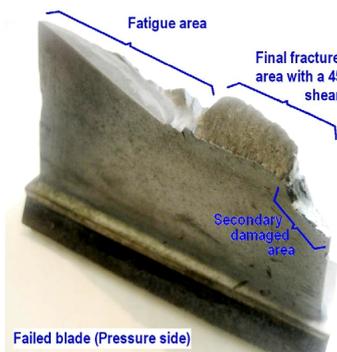
Figure 3 shows the surface of the fractured blade. In the fracture surface, fatigue fracture features (such as beach marks) can clearly be observed. Figure 3 also illustrates the fatigue area and the final fracture region with an angle of 45° (in trailing edge). Figure 4 shows that two semi-elliptical cracks are recognized and imply that the cracks extended from two different crack fronts. Also, beach marks are evident in this figure.

Figure 3. Fracture surface of the GTG D compressor's 1<sup>st</sup> row moving blade

Comparison of the areas of the fatigue region and the final fracture region in the fracture surface indicates that the final fracture has a small area in the fracture surface, so it can be concluded that the applied stress was low and the fracture mechanism is High Cycle Fatigue (HCF).

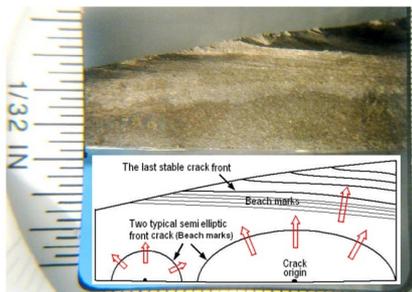
Figure 4. Fracture surface of blade

**3. 1. Fratography** Visual inspections show that the crack origins are two pits on the pressure side of the blade (Figures 4 and 9). The average value and measured values for striation spacing in different positions in Figure 7 are presented in Table 3.

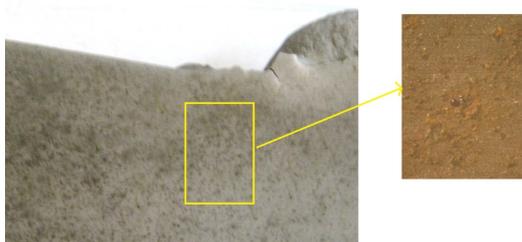
Figure 5. Brown spots on the pressure side of the blade

Airfoil surface is covered with tiny brown spots that represent signs of pitting. Density of these spots in the pressure side of the airfoil is more than in suction side (Figure 5).

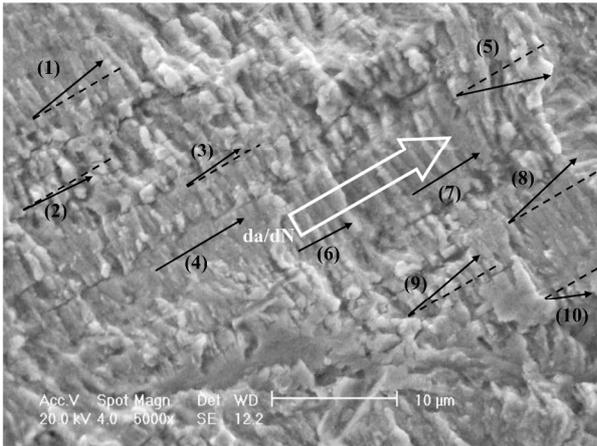
**Figure 7.** SEM (5000x) of middle section of big semi-elliptical; the big arrow is the direction of macroscopic crack growth, black arrows are directions of local crack growth direction and dashed lines are in direction of macroscopic crack growth in order to measuring  $\rho_p$  in Equation (5).

Line(p)	S <sub>p</sub> (μm)	Φ <sub>p</sub> (degree)
1	1	5
2	1.11	4
3	0.95	2
4	10.2	13
5	0.85	0
6	0.85	0
7	0.76	0
8	0.8	5
9	0.8	2
10	0.7	19

S (average)=0.876 μm

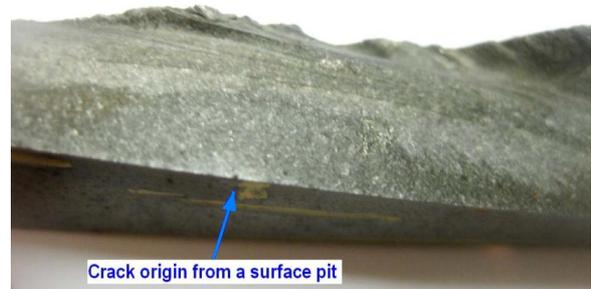
**Figure 9.** A view of the fractured bled surface with a pit on the pressure side.

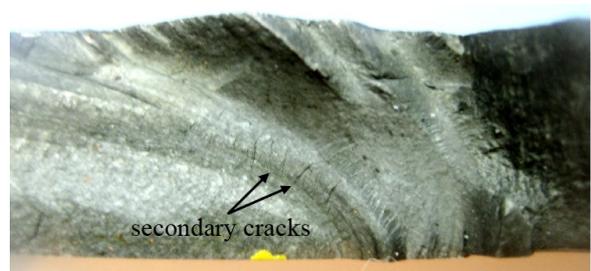
Near the final fracture zone, where the area of the blade becomes gradually smaller, stresses are very high and as a result of this high stress, secondary cracks have appeared. Figure 10 shows secondary cracks near the final fracture zone.

**Figure 10.** Presence of secondary cracks near the final fracture zone (high stresses)

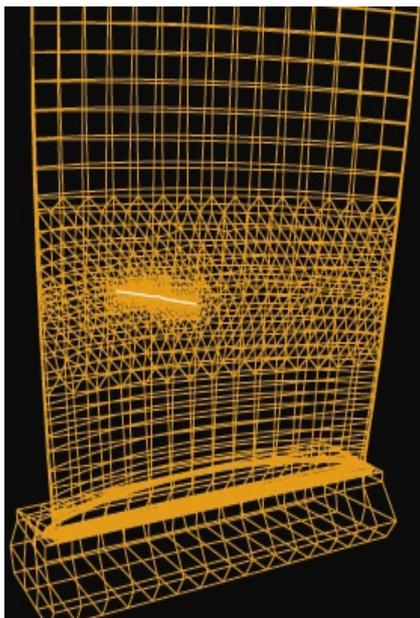
To verify the accuracy of calculations, the results were compared with numerical analysis in FRANC 3D [22]. According to the fractography of the fracture surface, the exact locations and dimensions of cracks were measured. After that, cracks were inserted into the model in FRANC3D (Figure 11). By applying the boundary conditions and the applied stress to the model, analysis was done and cracks were grown until the final fracture.

**Figure 11.** The bigger crack have been inserted to the model [22].

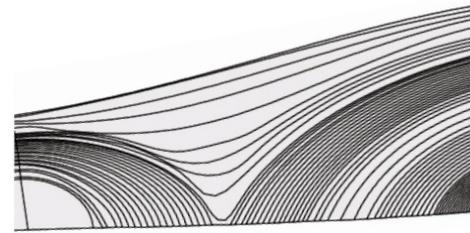
Figure 13 shows the changes of K along the crack front in different steps. The calculated value of  $\Delta K$  is for the stage of coalescence of two cracks (see Figure 12) and is in the range of numerical solution of K (see Figure 13-c). Figure 13 shows the computed life by numerical solution with different models. The

**Figure 12.** Coalescence simulation in FRANC3D [22]

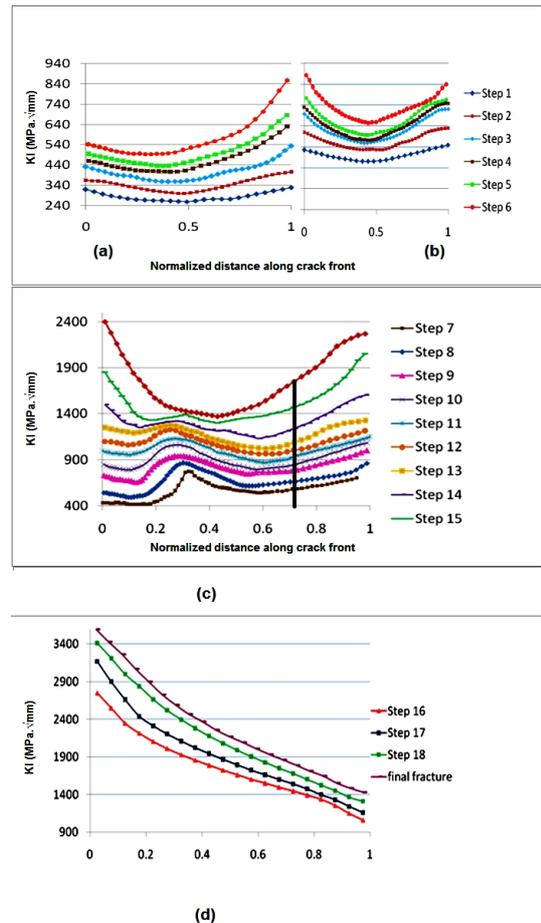
**Figure 13.** SIFs Curve in a) pre-coalescence for small crack b) pre-coalescence stage for big crack c) coalescence stage d) post-coalescence stage [22]

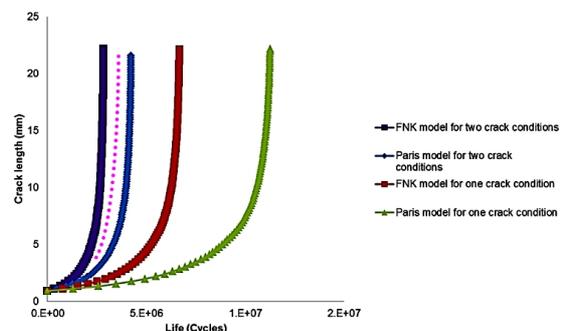
During the crack growth stage, with each incremental growth of crack length, the value of  $\Delta K$  increases. At the time of coalescence of two cracks, crack length increases spontaneously, and as a result, the value of  $\Delta K$  approaches to its ultimate limit ( $\Delta K_{lc}$ ). This increase in the  $\Delta K$  value occurs while in the case of one crack, more steps should be passed to achieve this amount. Therefore, the fatigue life in two-crack condition is less than one-crack state and numerical analysis confirms this issue (see Figure 14).

**Figure 14.** Crack growth curves [22]
