# DEALLOYING AND STRESS-CORROSION CRACKING OF COPPER ALLOYS IN $Cu(I)$ SOLUTIONS

T. Shahrabi

R. C. Newman

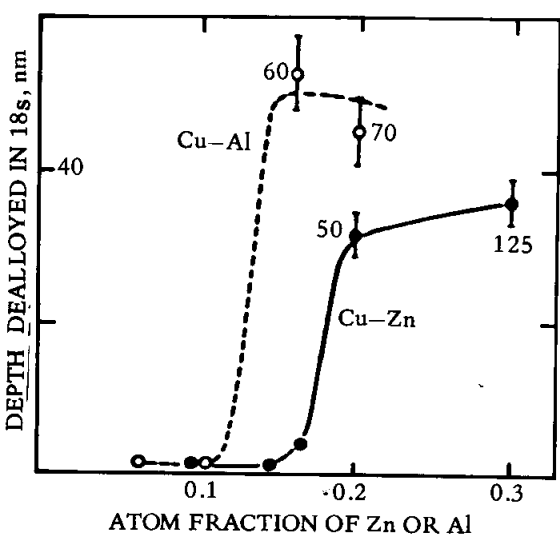
Figure 1. Dealloying of Cu-Zn and Cu-Al alloys, as measured in scratch tests at  $0 V_{Cu}$  in 15M NH<sub>3</sub> + 0.05M Cu solution [1]. The numbers next to the data points denote the SCC velocities, in nm/s, measured in slow strain rate tests of monocrystals in the same solution; no number indicates no SCC.

Figure 1 shows the correlations between dealloying and SCC for Cu-Zn and Cu-Al alloys in cuprous ammonia solutions [1]. In these solutions the dealloying is very superficial, as indicated by the lack of color

change of the brass over periods of several days, but the first few hundred of attack occurs quite rapidly—typically at  $\sim 1$  mA/cm<sup>2</sup>. This contrasts with cuprous chloride solutions (Figure 2), where sustained dealloying can be obtained to depths of mm [2]. This macroscopic dealloying has an inverse correlation with SCC in this system. The presence of 0.03% As was shown to inhibit dealloying almost completely.

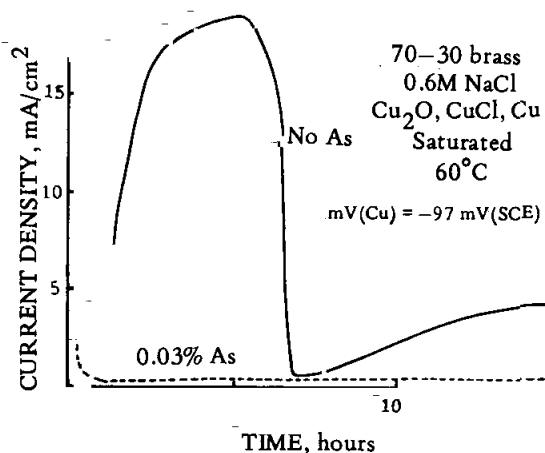
Figure 2. Dealloying kinetics of 70-30 brass, with and without arsenic, in 0.6M NaCl stirred with excess Cu, CuCl and Cu<sub>2</sub>O at  $0 V_{Cu}$  and 60°C [2].

Figure 2 shows the typical behavior of the brasses in the 3.5% NaCl solution equilibrated with Cu,  $\text{Cu}_2\text{O}$  and CuCl at 60°C. The potential in this test was -97 mV (SCE). The result for the Cu-30Zn alloy was not perfectly reproducible in the early stages, as the initiation of dealloying in the air-formed oxide film was localized, giving an initially hemispherical layer growth [2] as shown in Figure 3. The two layers in each hemispherical region correspond to the material formed before and after the abrupt drop in the current after ~ 6 hours in Figure 2; this drop was reproducible and may be due to a blocking of porosity in the layer by copper plating from negatively charged cuprous ions ( $\text{CuCl}_2^-$ ) migrating into the layer under the influence of the ohmic potential gradient [2]. The inner layer has been found to retain a few percent of zinc, while the outer layer is essentially pure copper.

Clearly this type of test has considerable potential for alloy testing development, since it neatly displays the inhibiting effect of alloyed arsenic as shown in Figure 2.

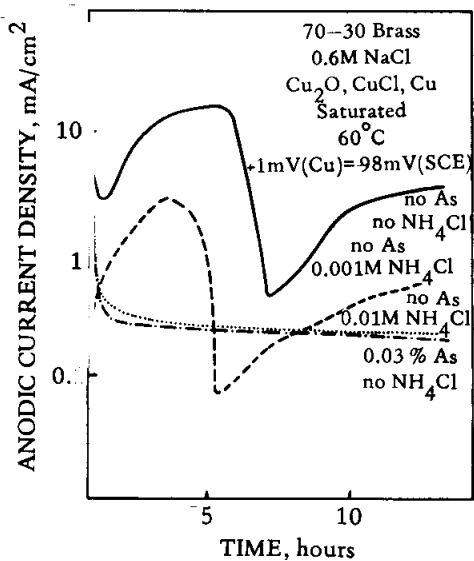
Figure 4. Current-time curves for 70-30 brass, with and without arsenic, showing the inhibiting effect of adding  $\text{NH}_4\text{Cl}$  to the solution used in Figure 2.

Addition of  $\text{NH}_4\text{Cl}$  to the 3.5% NaCl solution dramatically inhibited the dealloying, and at 0.01M  $\text{NH}_4\text{Cl}$  there was scarcely any difference between the 30Zn and 30Zn - 0.03As alloys (Figure 4). No dealloying was detectable on polished cross-sections of these surfaces. The effect of  $\text{NH}_4\text{Cl}$  on the potential of the copper reference electrode was less than 1 mV - not surprisingly, as the pH of the solution is 5.1

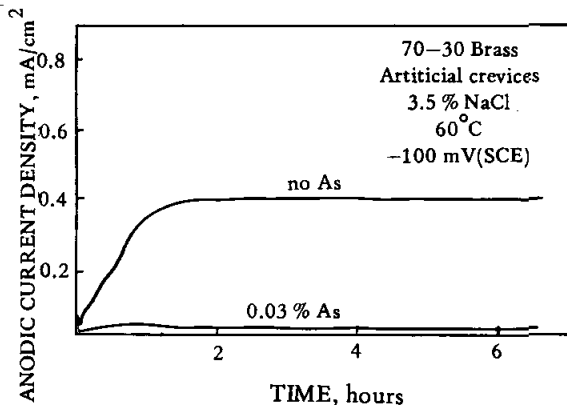
Figure 5. Current-time curves for artificial crevice specimens of 70-30 brass, with and without arsenic, in 3.5% NaCl solution without cuprous ions at  $60^\circ\text{C}$  and  $-100\text{ mV (SCE)}$ .

The crevices tests in NaCl solution at  $60^\circ\text{C}$  and  $-100\text{ mV (SCE)}$  gave a good indication of the beneficial effect of arsenic, as shown in Figure 5. Because of the crevice geometry, there was a significant IR potential drop, and the anodic current density on the non-arsenical alloy was much less than in Figure 2. There seems to be no pressing reason to use artificial crevices in any standard electrochemical test procedure, (where the current is the criterion of dealloying) but they could be useful for a potentiostatic immersion test in which the dealloying is evaluated metallographically.

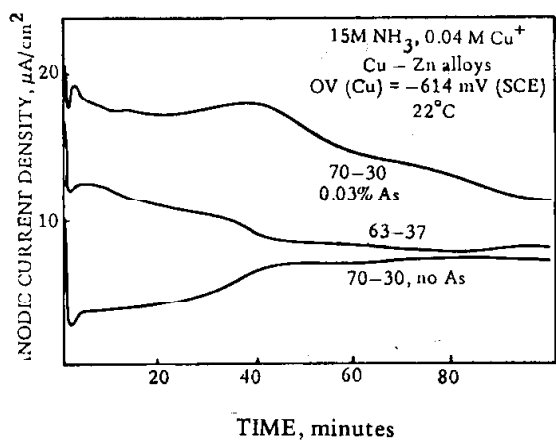
Figure 6. Dealloying kinetics of 30Zn, 30Zn-0.03As and 35Zn ("37Zn") brasses in cuprous ammonia solution.

The small extent of dealloying was confirmed by the lack of a color change on specimens immersed for many hours at  $0\text{ V}_{\text{Cu}}$ . Figure 6 displays typical current - time curves for three alloys, indicating that alloyed arsenic has little or no effect on this superficial form of dealloying - in fact it reproducibly gave higher current densities. This is consistent with the well - known susceptibility of arsenical brasses to ammonia-induced SCC [12]. The "37%" (actually 35%) alloy dealloyed significantly more rapidly than the 30% non-arsenical alloy, as might be expected.
