Influence of Multiple Repairs on the Quality of Duplex Welded Joints

Duplex stainless steels (DSSs) find increasing use as a substitution to austenitic stainless steels in oil, gas and petrochemical industries, particularly in aggressive environments. Duplex stainless steels with appropriate controlled ferrite-austenite balance combine the attractive properties of excellent strength, general corrosion performance and adequate weldability. All the welding joints subjected to the regulation must be controlled before commissioning the pipeline and even before hydrostatic tests; all not acceptable defects detected with **non-destructive testing** (NDT) control methods must be eliminated. In some cases, several successive repairs are often preferred to part replacement in the pipeline due to lack of experience of the welder performing the repairs or lack of expertise of the controller ensuring the application of the welding procedure. The purpose of this work is to study the influence of repairs on the same welding joint on the microstructure and the mechanical properties of the heat-affected zone in duplex stainless steel with 22% chromium welding joints. For this purpose, a cylindric

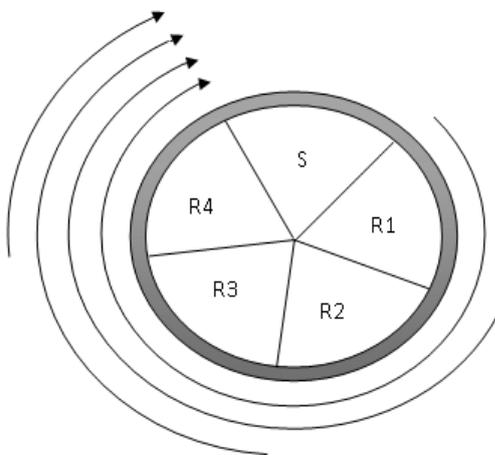
Figure 1. Repair technique on the same welding joint (Repair sequences).

mechanical properties of the welding joint. The technique adopted in the present work for carrying out the repairs is presented in Figure 1. The advantage of this original technique lies in the fact that the obtained test pieces belong to the same coupon, in which the metal used is duplex stainless steel with 22% of chromium intended for the hydrocarbons transmission in particular gases and aggressive products. This study requires the realization of the welded specimens, a visual and radiographic control, an in-depth examination of the micrographic structure, and mechanical tests.

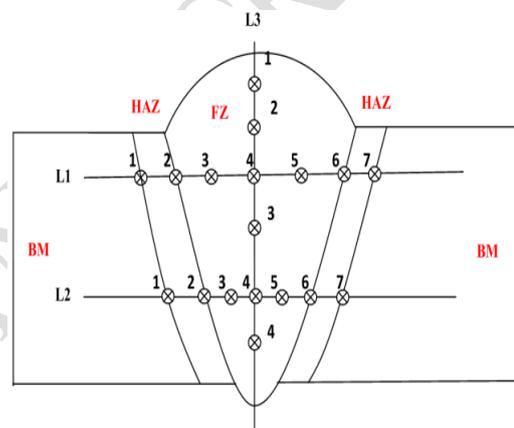
Figure 3. Hardness points measurements

The hardness tests were carried out using a Chartip 3000 hardness tester on a well-polished flat surface. Measurements of hardness were taken in the longitudinal direction (lines L1 and L2) and transversely (lines L3) of the welding joint, which allows the evaluation of the hardness profile (Figure 3).

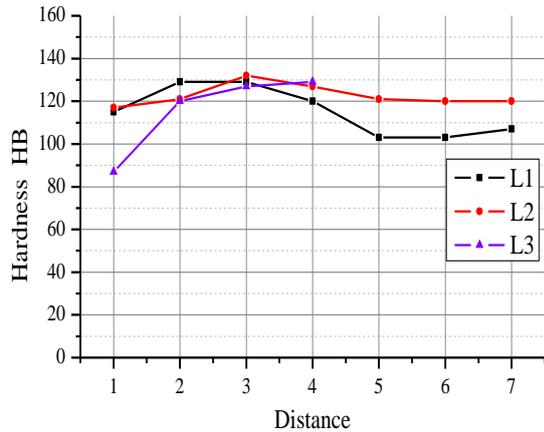
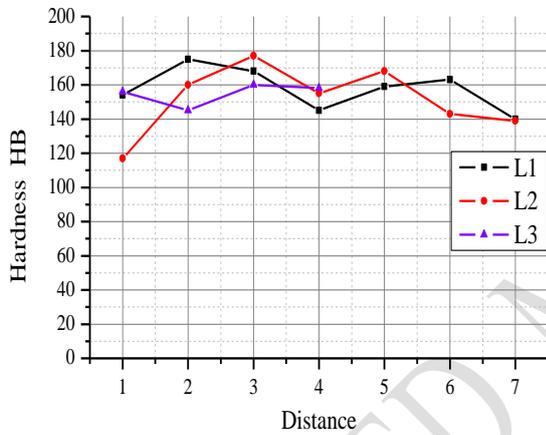
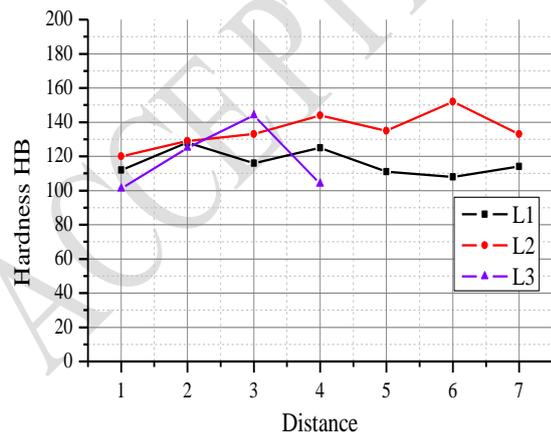
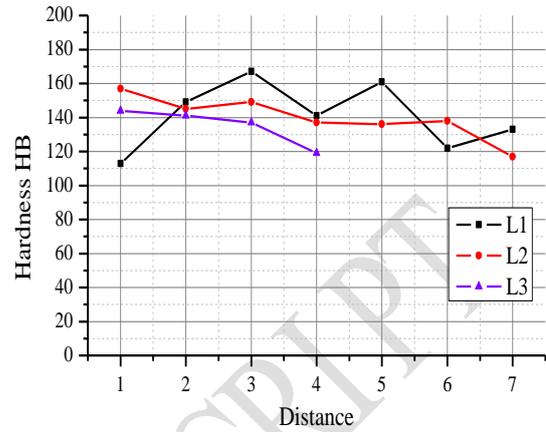
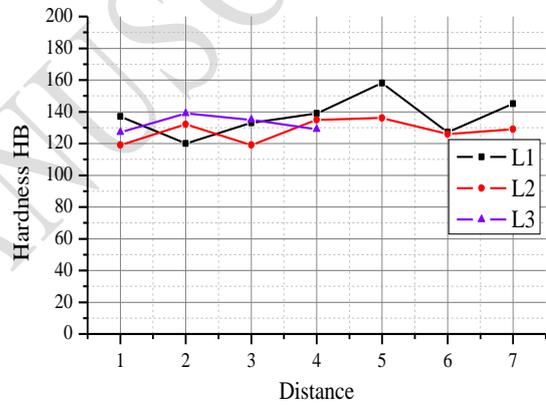
Figure 4. Hardness values a) before repair, b-e) after successive repairs

The values of hardness are homogeneous and acceptable according to ASTM specification, whether in the longitudinal or transverse direction, since the succession of passes give a similar effect to heat treatments as noted in Figure 4.

a) Hardness without repair

d) Hardness after third repair R3

b) Hardness after first repair R1

e) Hardness after fourth repair R4

c) Hardness after second repair R2

According to hardness values, it can be seen that, the hardness evolution is relatively variable; this can be attributed to the diffusion of Mn and Si from the base metal to the heat-affected zone (HAZ) and the fusion zone (FZ), as well as the concentration of the heat input.

The growth of the grains in the second and third repair is probably due to the repetitive thermal cycles of the welding process, causes a decrease in the hardness in the HAZ. The high hardness of the fusion zone may be related to the formation of acicular ferrite. The hardness values are higher in this region compared to those observed in the lower part (root pass). The refining of grains and the increase in the density of dislocations in the HAZ of the first repair increases the hardness. However, the molten metal of the weld is not homogeneous, which is the case for all multi-pass welds (Figure 4). The internal pass has higher hardness than the external pass, which can be explained by a slower cooling when welding the external pass.

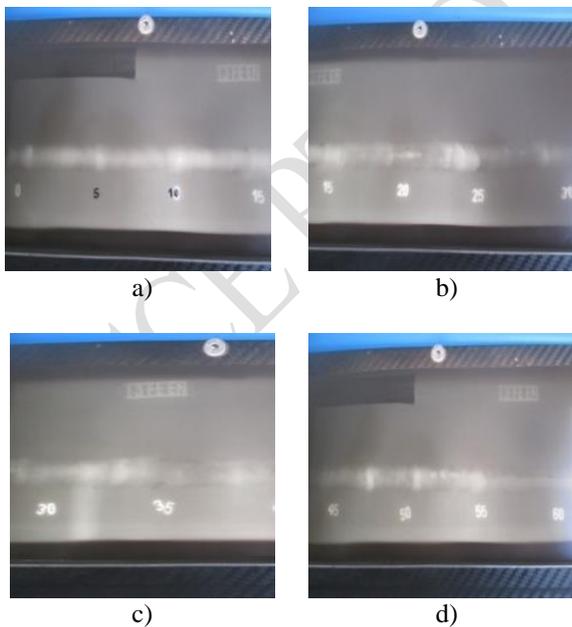
Figure 5. Radiographic stereotypes before repairs

Radiographic inspections were carried out by means of the gamma rays Ir192, D7 films gave the following stereotypes before repair (Figure 5) and after repairs (Figure 6).

Radiographic films present concavity defects from 25 to 30 (Figure 5b), lack of matter and excess of penetration from 20 to 25 (Figures 5b and 5d), an undercut defect from 35 to 40 (Figure 5c), a concavity and lack of fusion from 55 to 60 (Figure 5d), and a film presenting a lack of penetration from 60 to 70 (Figure 5e).

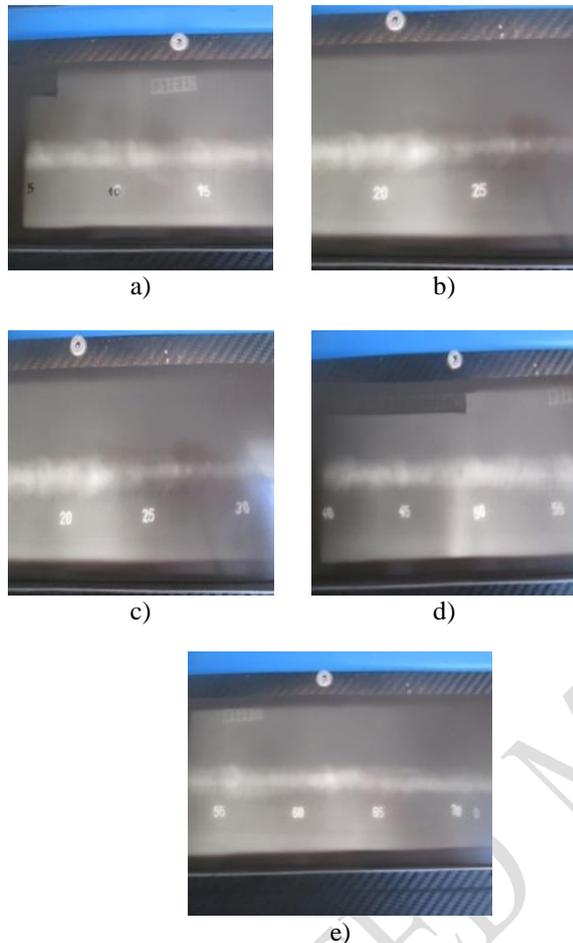
Figure 6. Radiographic stereotypes after repairs

This film (Figure 6c) shows the grinding traces from 22 to 32. All the rest of stereotypes reveal joints with acceptable defects.

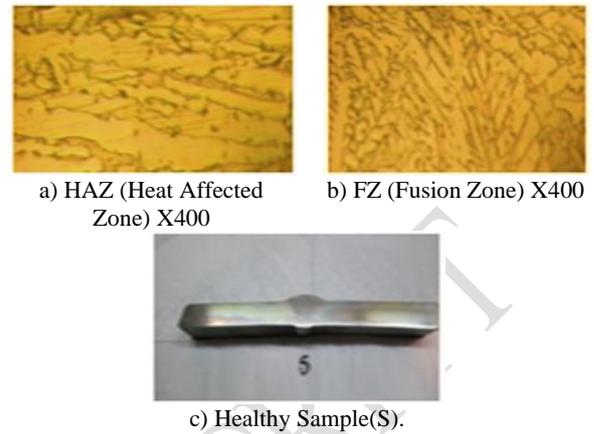
Figure 7. Micrographs before repair
After the first repair (R1)

The metallographic control for healthy(S) and repaired (R1 to R4) samples gave the micrographs represented in Figures 7-11.

The visual aspect of all the parts has an homogeneous structure without apparent defects, the succession of the passes is not visible (fillers of even similar close nuances).

Metallographic samples were prepared in welding joint cross-section. The micrographs using light microscopy up to 400X illustrate an austenitic-ferritic two-phase structure, the dark color is ferrite while the light color is austenite, we also notice the absence of the sigma phase as shown in Figure 12. The heat affected area width is from 2 to 4 mm and it is similar from R1 to R4.
