Earthquake Evaluation of the Non-Structural Elements in a Thermal Power Plant

In this paper, only the seismic evaluation of the Non-structural components of the main control building will be presented which are conducted based on MCEER, FEMA-310 and FEMA-356 recommendations.

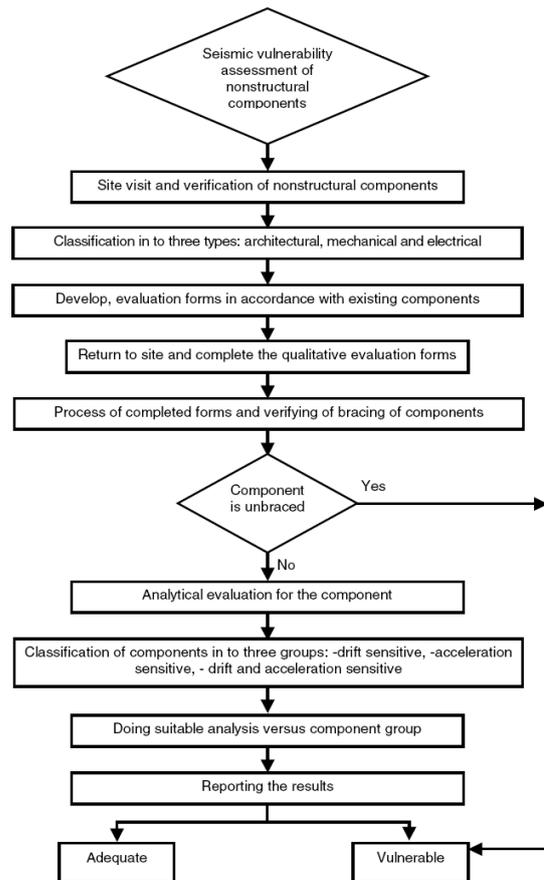
Figure 2. Flow chart used for the evaluation

For the evaluation of the mechanical and electrical equipments, at first, qualitative evaluation was performed based on MCEER and quantitative evaluation was performed based on FEMA-356. For this aim, at first some checklists were designed based on MCEER evaluation forms with some modifications to calibrate to the local conditions. These forms were then filled out by visual screening for different equipments separately. Equipments which did not have adequate anchorage and lateral bracing were reported as vulnerable equipments. Then, quantitative evaluation of equipments which did have enough anchorage and lateral bracing for stability during earthquakes were performed based on the proposed analytical and loading methods of FEMA-356 for adequacy check of selected types of equipments. Flow chart of the evaluation method used in this study is shown in Figure 2. Paramount vulnerability items in equipment evaluation checklists are summarized here as:

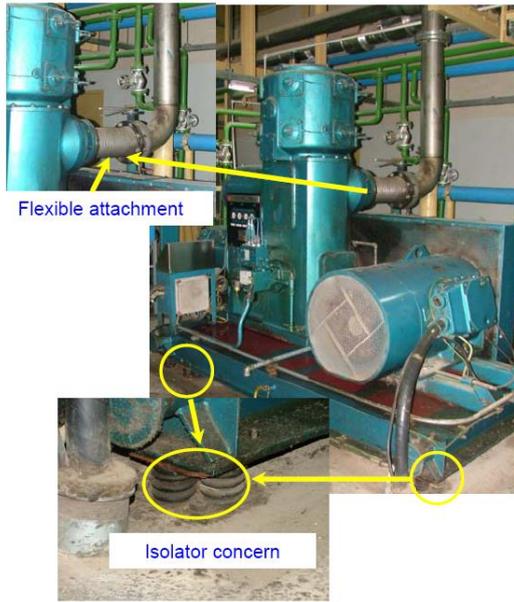
Industrial equipments located on the ground floor, were classified as mechanical and electrical equipments only. Most of the mechanical equipments at the ground floor have concerns regarding rigid attachments of the vibration isolator and piping supports that finally classified as low and intermediate hazard levels. Some samples of the concerns related to these equipments are shown in Figures 4 to 7.

Figure 4. Isolator concern

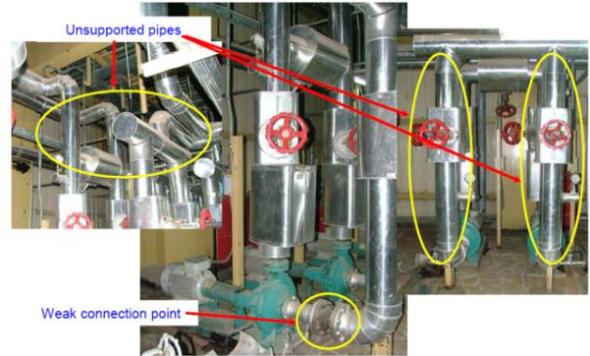
Figure 7. Unsupported pipes which connected by a weak connection point

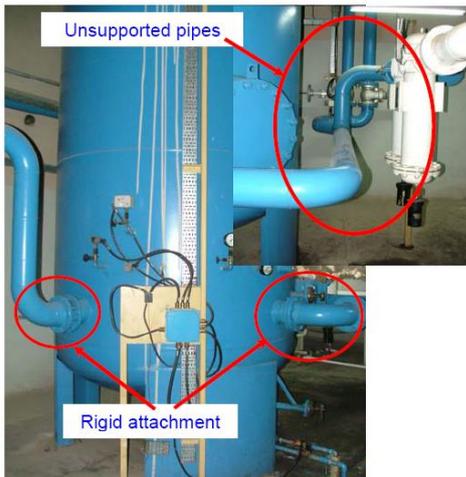
Figure 5. Rigid attachment of unsupported pipes

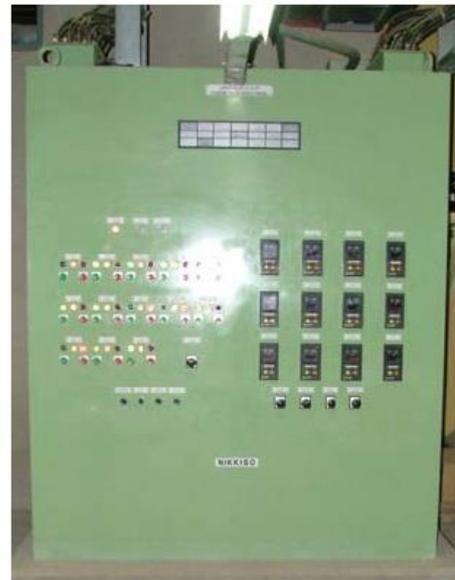
Electrical equipments at the ground floor, as well as the distribution panels, switch gears and motor control centers did not possess any important concerns and thus classified as low vulnerable=SAFE hazard level. A sample of these equipments is shown in Figure 8.

Figure 8. A sample of electrical equipments at the ground floor

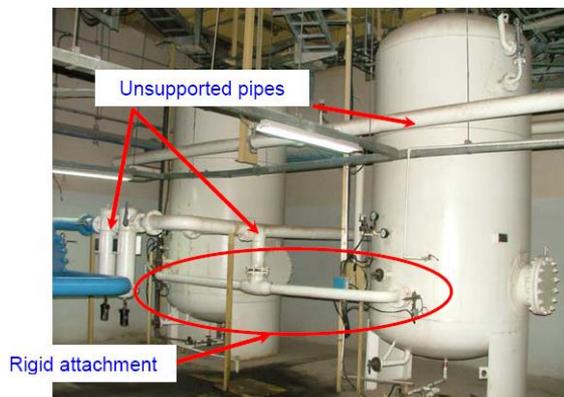
Figure 6. Rigid attachment of unsupported pipes

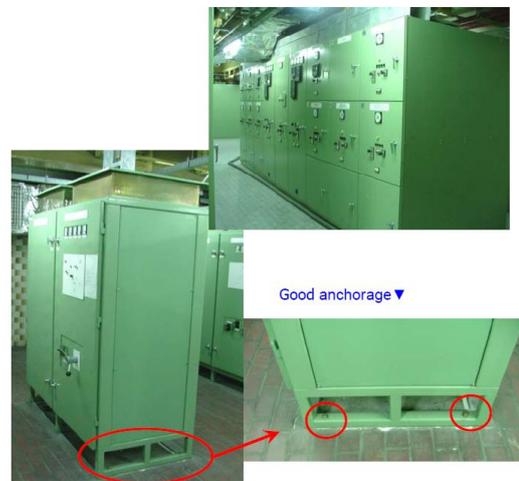
Figure 9. Some samples of control equipments which have a good anchorage

These equipments were classified as low vulnerable=SAFE hazard level because of the good anchorage and lack of any above mentioned concerns. Samples of these equipments are shown in Figures 9 and 10.

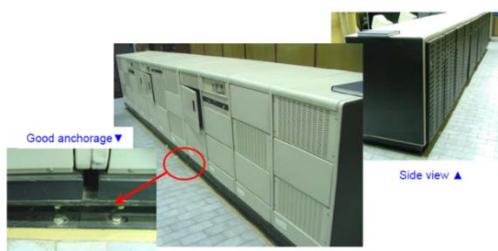
Figure 10. A sample of electrical control equipments which has no any concerns

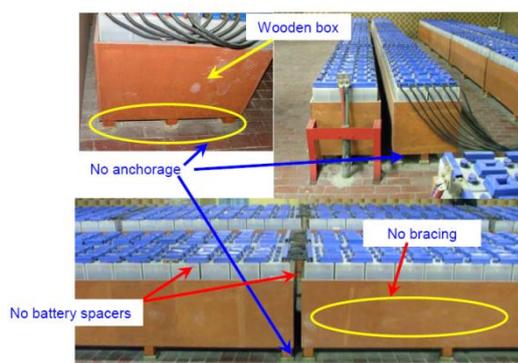
Figure 11. Some samples of battery racks with no anchorage, no bracing and no battery spacers concerns

Batteries and racks which exists throughout different levels of the building, were considered as electrical equipments and classified as very high vulnerability hazard level. Because of the no anchorage, no battery spacers, no longitudinal cross bracing and no battery restraints concerns. A sample of these equipments is shown in Figure 11.

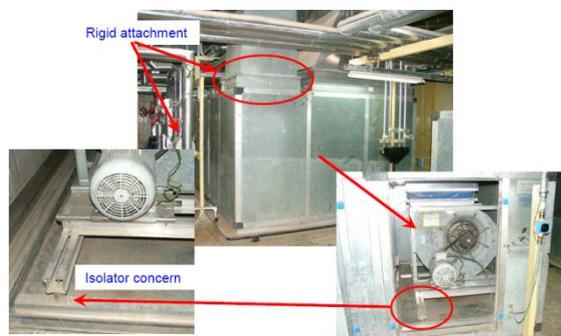
Figure 12. A sample of air conditioning equipments at the end story which has rigid attachment and isolator concerns

Air conditioning equipments of the control building which are located on the end story and roof levels of the building were considered as mechanical equipments which mostly have base isolator concerns and were classified as high vulnerability hazard level. Vulnerability of these equipments does not have important effects on the performance of the building. However, they poses some sort of hazard. Samples of these equipments are shown in Figures 12 and 13.

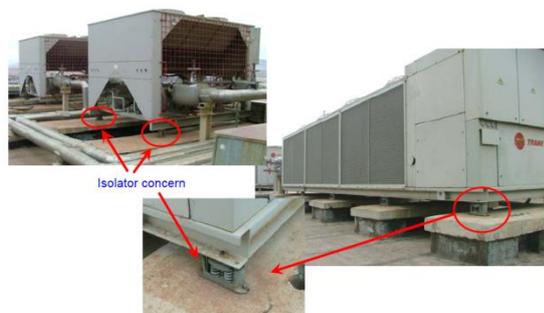
Figure 13. Some samples of equipments on the roof level which have rigid attachment and isolator concerns
