Analysis of the Crankshaft Failure of Wheel Loader Diesel Engine

The main purpose of this study is to review the cause for the crankshaft failure of six-cylinder diesel engine of a wheel loader after passing a short period of time. The failure had occurred after 4800 hours of in-service in the fifth crankpin of the crankshaft. Hardness and tensile tests were carried out to study their mechanical properties. Spectrophotometer machine was used to examine the chemical composition of the crankshaft material. To examine the material microstructure, its defects and the morphology of fracture surface, optical microscopes (OM) and scanning electronic microscopes (SEM) equipped with energy dispersive spectrometry (EDS) were used. The morphology of fracture surface showed that the fracture is of the smooth type and has occurred due to the fatigue. Main origin of the fatigue cracks appeared on the surface of the crankpin might be created by the existence of oil impurities, the impurities on the surface of the crankpin, inappropriate machining on the surface of the crankpin or severe wear and pitting from insufficient lubricating.

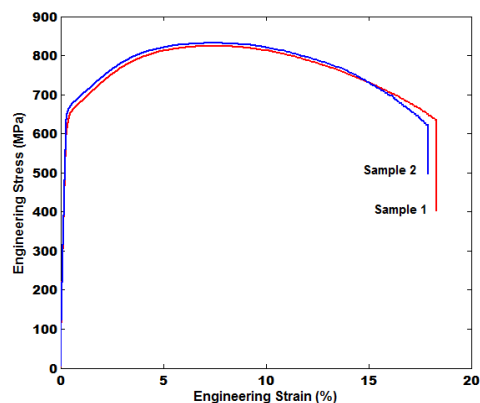
Figure 4. Engineering stress vs. engineering strain curves of crankshaft material

σ_Y (MPa)	Symbol	Elong. (%)	σ_U (MPa)
Standard alloy	Min. 650	900-1100	Min. 12
Sample 1	647.65	823.92	18.34
Sample 2	671.25	832.3	17.9

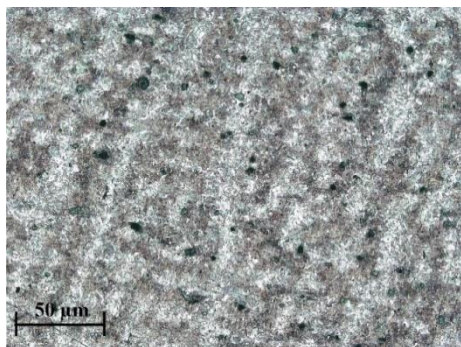
Figure 7. Micrograph of the material etched with 500x magnifications

A cross-section microstructure of crankpin was observed using OM. Figure 6 shows the micrograph of the crankpin no. 5 after polishing with 1000x magnifications. The oxidized inclusions are found in great amounts on the polished areas. Figure 7 shows the micrograph after being etched. The tempered martensite structure was observed which hardness measuring approves the results.

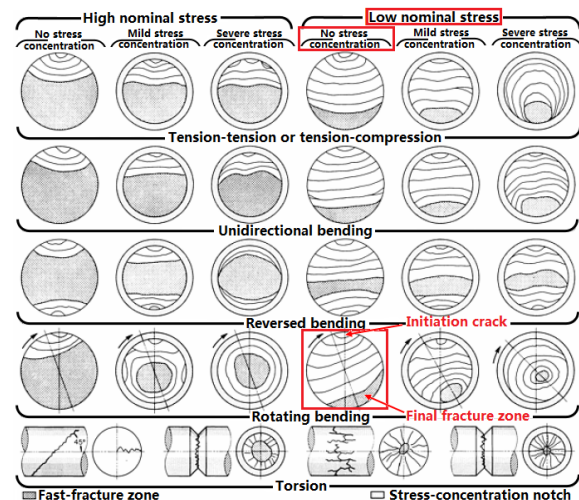
Figure 9. Schematic representation of fatigue fracture surface marks in shafts [18].

Comparing the fractured surface of Figure 8 with the schematic guidelines of Figure 9 on the fracture surface of the shafts [17, 18], the following specifications can be referred to: (1) high cycle; (2) low stress with the small zone of the final fracture compared to the wide cross-section of the whole crankpin due to the cyclic stress caused by rotational bending loads; and (3) a medium stress concentration.
