Corrosion Failure Study in an Oil Cooler Heat Exchanger in Marine Diesel Engine

In this article, the failure of a heat exchanger during its operation in the marine environment has been analyzed. This heat exchanger was used for cooling the oil in a marine diesel engine. Based on the existing failure history, damages in engine components were observed after 89 hours of engine working due to the leakage of the sea water to the oil. For the objective of the failure analysis, each component was investigated under the stereo optical microscopy and the scanning electron microscopy (SEM). The diameter of pits was also recorded as 8 micrometer. Besides, the chemical composition of corrosion products on the surface and in pits was additionally analyzed with the energy dispersive X-ray spectroscopy (EDAX). Results indicated that two corrosion mechanisms were failure root causes of leakages, including the crevice corrosion and the pitting corrosion. In such situation, in the engine, the oil and the sea water in tubes of the heat exchanger mixed and decreased the oil viscosity and damaged the oil film on crankshaft bearings, and finally caused damages of the engine.

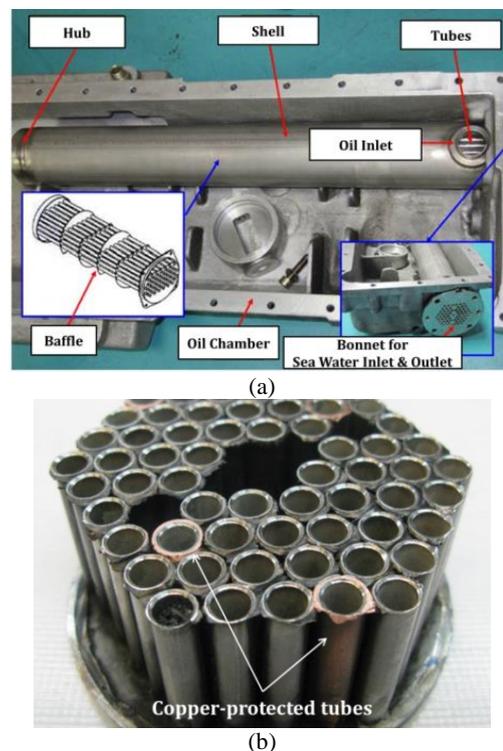
In marine diesel engines, to cool the oil, heat exchangers are widely used. These heat exchangers are placed in the oil chamber and utilize the sea water for cooling the engine oil. Components of this cooling system can be seen in Figure 1(a). According to this figure, the heat exchanger includes tubes and a shell. The engine oil moves through the shell and the sea water moves through tubes. Tubes, made of 316L stainless steel are brazed to the tube sheet made of brass. There are also some baffles to cause turbulence for better heat transfer.

Maximum sea water and oil pressure are 2.8 bars, respectively. Maximum temperature of in the sea water and the oil are 50°C and 100°C, respectively. In order to protect tubes against corrosion, some tubes have copper coating as the cathodic protection in the oil environment, as shown in Figure 1(b). In addition, some cathodic protection bolts are placed through the sea

Figure 1. (a) Components of the heat exchanger for the engine oil cooling system and (b) the cross section of tubes
