Evaluating Applicability of ASTM C 928 Approach in Assessing Adequacy of Patch Repair of Bridge Piers

S. Rahmzadeh, S. Tariverdilo*

Department of Civil Engineering, Faculty of Engineering, Urmia University, Urmia, Iran

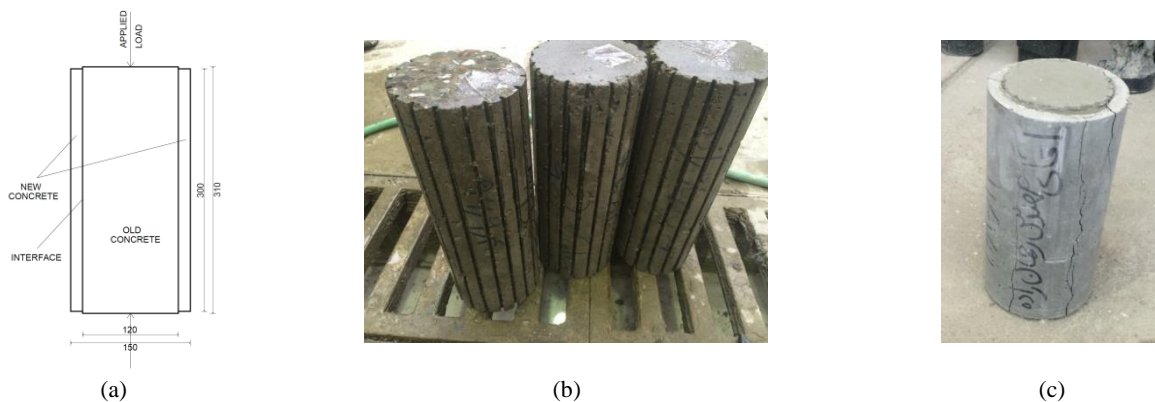
Figure 1. Patch test specimen, a) dimensions, b) damaged concrete (old concrete) of diameter 120 mm, c) tested specimen

The patch test specimens consist of a core cylinder of height and diameter of 310 and 120 mm from old concrete, and a surrounding cylinder from repair concrete of 300 mm in height with interior and exterior diameter of 120 and 150 mm (Figure 1a). Compression load is applied through old concrete, and there is no direction load application on the top and bottom surfaces of repair concrete .

The lateral surface of damaged samples (interface) is roughened by longitudinal grooves of width and depth of 4 mm and with spacing of 20 mm (Figure 1b). A specimen ready for test is shown in Figure 1c. Table 3 also gives strength of different concretes (old and repair concrete) used in the tests. The repaired samples were cured by 1 day dry, 3 days water curing, and then 24 days with nylon coating in the laboratory condition ($20 \pm 2^\circ\text{C}$). The repaired samples were loaded under compressive axial load 28 days after repair and their load-bearing capacity and axial deformations were read .

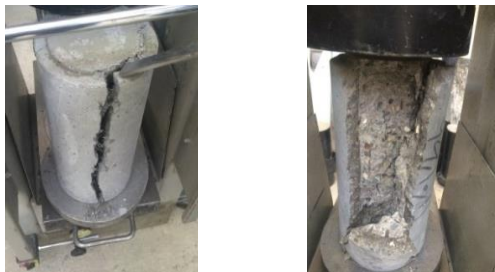
Figure 4 depicts cracking pattern of two specimens in the patch test. The first crack in the repaired samples are longitudinal cracks in the surface of repair concrete. Due to the application of the load on the core concrete, the formation of longitudinal cracks in repair concrete have been due to different modulus of elasticity and consequently different transverse deformation of the core and repair concrete. In the repaired specimens, four longitudinal cracks occur at approximately equal radial angles.

Figure 4. Cracking pattern of repaired specimens in patch tests

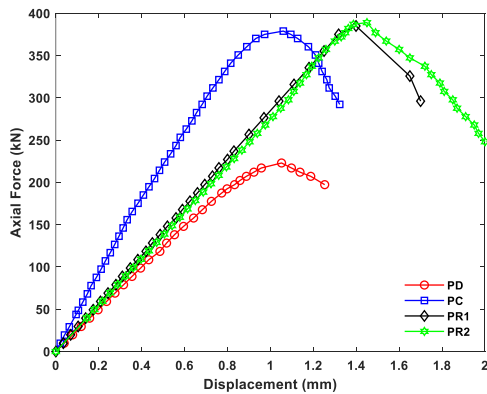
The load-displacement curve for different specimens is shown in Figure 5. The maximum load carrying capacity of repaired specimens (PR1 and PR2) barely exceed that of control specimen (PC). Figure 6 gives minimum, maximum and mean of different specimens evaluated using the patch test. The results of the compression test on the patch specimens could be summarized as follows:

Figure 5. Typical load-displacement of specimens in patch test

- The mean load carrying capacity of the control and damaged samples (PC versus PD) are 389 and 226 kN respectively. This shows a reduction of about 42% for damaged samples. It should be noted that the cross-sectional area of core concrete in damaged samples is reduced by 36% compared to the control samples.
- Introduction of damage resulted in about 60% reduction in axial stiffness. Repair attempts introduces no improvement in increasing stiffness of the repaired samples.

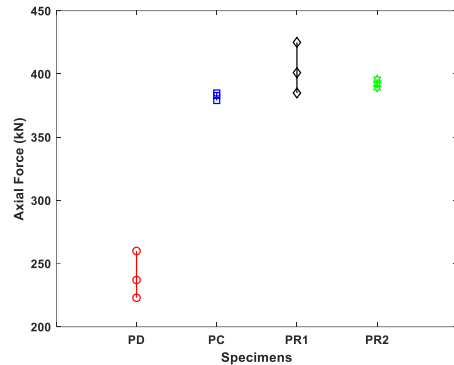
Figure 6. Results of patch tests including minimum, mean and maximum axial strengths

- Samples repaired by PM-SCC has a mean load carrying capacity of 387 kN, which shows an increase of about 71% compared to the damaged samples and slightly lower than the control specimen.

- Samples repaired using FR-PM-SCC has a mean load carrying capacity of 392 kN, an increase of about 73% compared to the damaged samples and slightly larger than the control specimen.

- Introduction of damage increases anticipated variation in the specimen’s strength. On the other hand, the use of fiber reinforced repair concrete significantly reduces the variation in the strength.

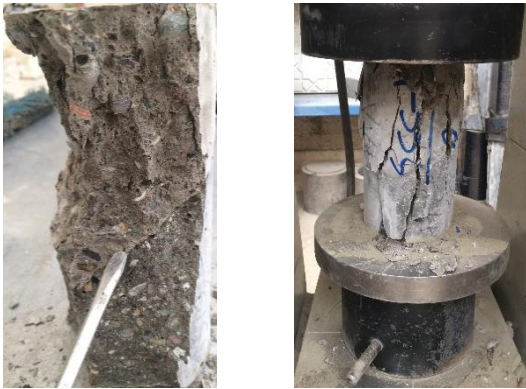
Figure 7 depicts failure pattern of two specimens tested using the slant shear test method. Interface between the two concretes is also visible in one of the figures. Figure 8 depicts results of the tests. By reviewing results for different specimens, the following conclusions could be drawn:

Figure 7. Failure pattern of typical specimens in slant shear tests

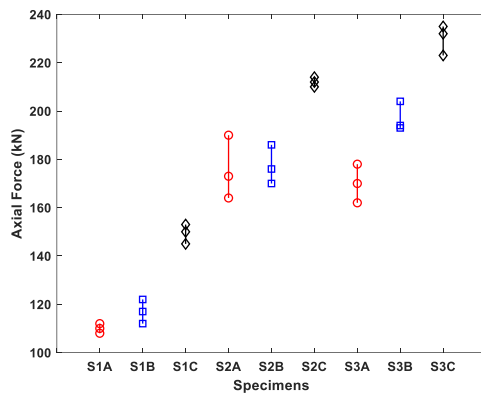
Figure 8. Results of slant shear tests including minimum, mean and maximum strengths

- In specimens repaired by PM-SCC or FR-PM-SCC, there is about 50% increase in strength compared to the specimens repaired by NSC. It can be inferred that the use of SBR latex polymer has significant effect on the adhesion between old and repair concrete.
- Different surface treatment methods have substantial impact on the strength of the repaired specimen. Increased effort in preparing interface from smooth to brushed and grooved surfaces, increases the strength of the specimens. No interface failure is observed for specimens with minimal surface

preparation attempt, i.e. specimens with brushed or grooved interface.

- There is reduced sensitivity to the interface preparation method in the specimens repaired by PM-SCC or FR-PM-SCC concrete. This is another indication of superior performance of latex in improving bond strength between old and repair concrete.
- Making use of fiber reduces anticipated variation in the results of slant shear strength. The same pattern is also observed in patch tests.
- Referring to Tables 3 and 4, strength of repair materials is smaller than those used in the patch test, however the results of the slant shear test shows more efficient repair.

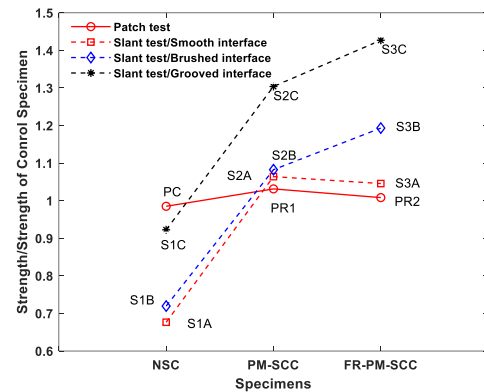
Figure 9. Evaluating correlation between slant shear and patch tests

(section 4.1) and slant shear tests (section 4.2) is evaluated. Figure 9 shows the efficiency of different repair methods compared with the compressive strength of the old concrete as assessed using two different testing methods. It is anticipated that as the patch test accounts for indirect load transfer to the repaired concrete, it provides a better estimate of the repaired element. As could be seen, while use of latex significantly improves strength evaluated by the slant shear test results, there is only a slight increase in the strength as assessed by the patch test.

In patch repair, due to the short length of the repair, the repaired concrete could not be considered fully effective. Indirect load transfer from old concrete to repair concrete in patch repair could not be simulated by the slant shear test. Accounting for load path in patch repair, strength of the old concrete introduces a limit on the maximum efficiency of the repair material and method. The slant shear test is more appropriate for testing continuous shear transfer in elementwise repairs rather than local patch repairs.
